Investigation of L'Ambiance Plaza Building Collapse in Bridgeport, Connecticut

Center for Building Technology
National Engineering Laboratory
National Bureau of Standards
Gaithersburg, MD 20899

Charles G. Culver
Charles F. Scribner
Richard D. Marshall
Felix Y. Yokel
John L. Gross
Charles W. Yancey
Erik M. Hendrickson

Issued September 1987

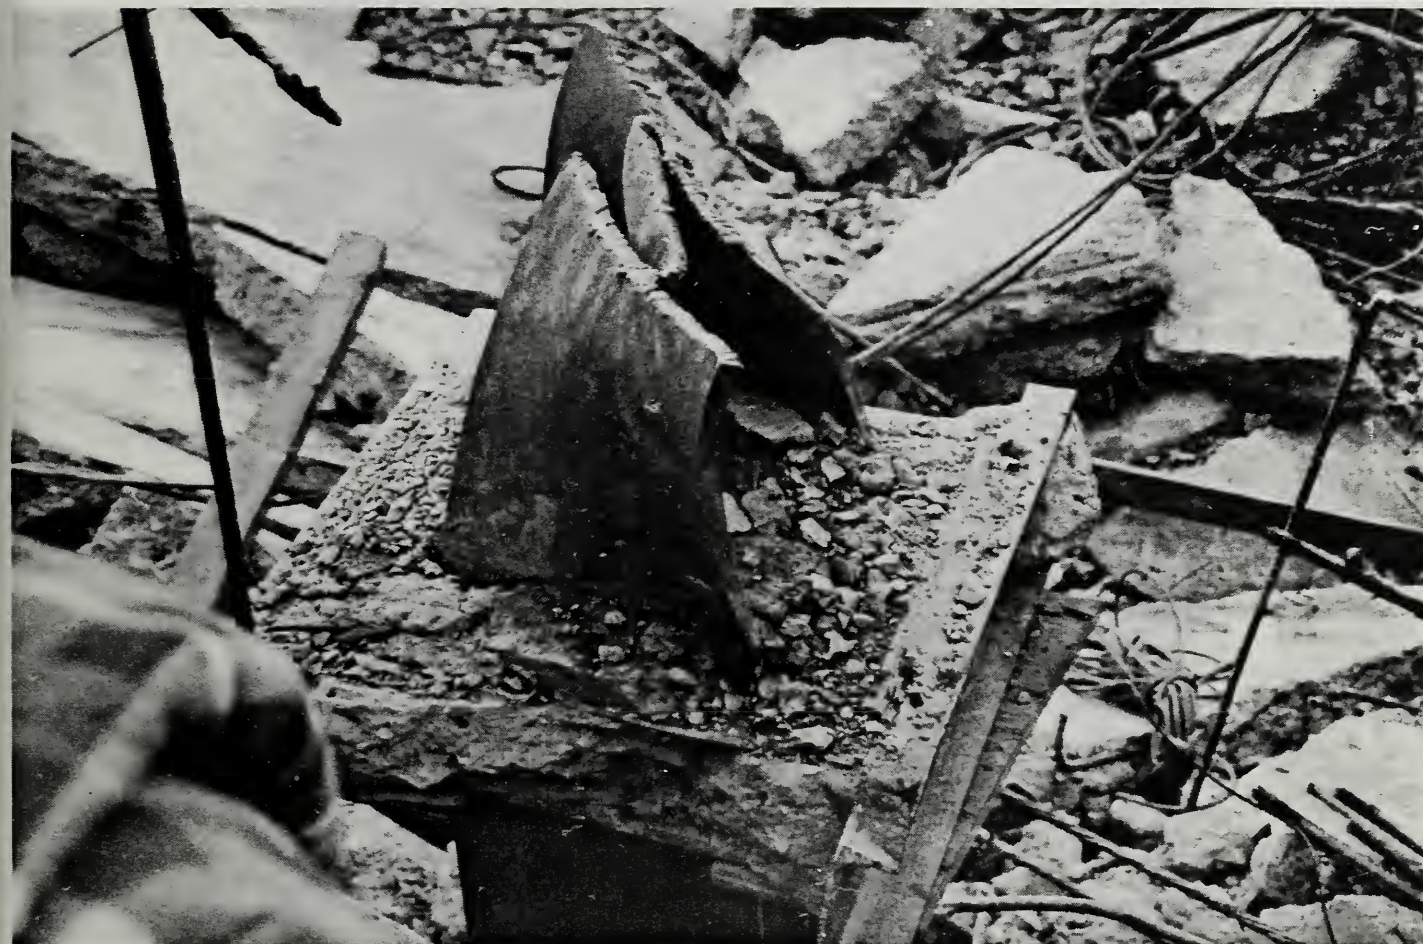
Figure 4.4.6 Twisting deformation of column in West tower

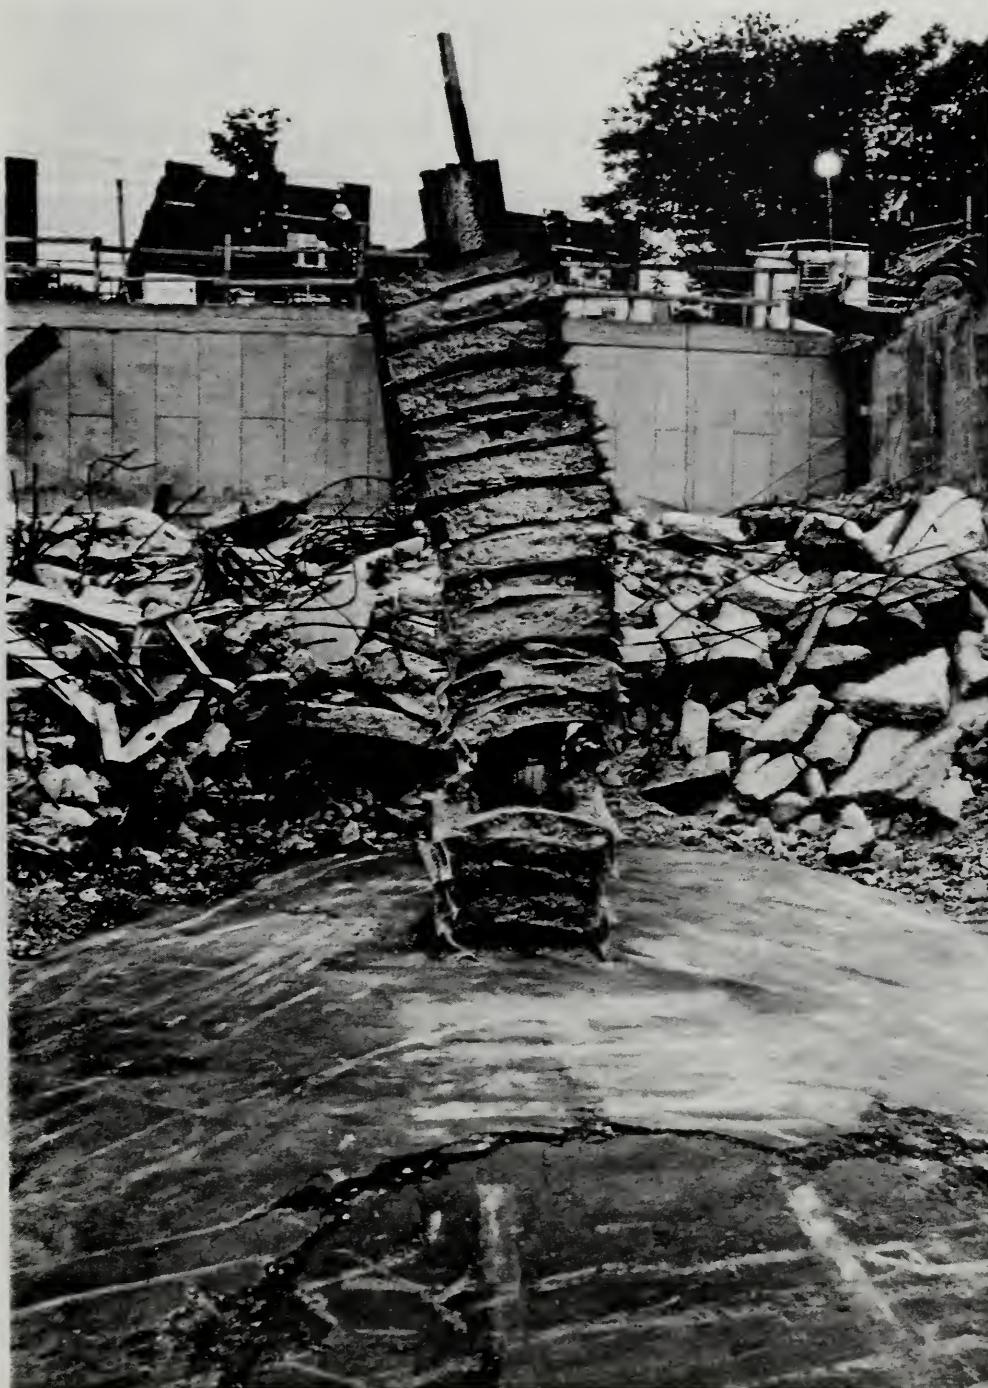
Figure 4.4.18 Deformation pattern of shearheads
– column D10

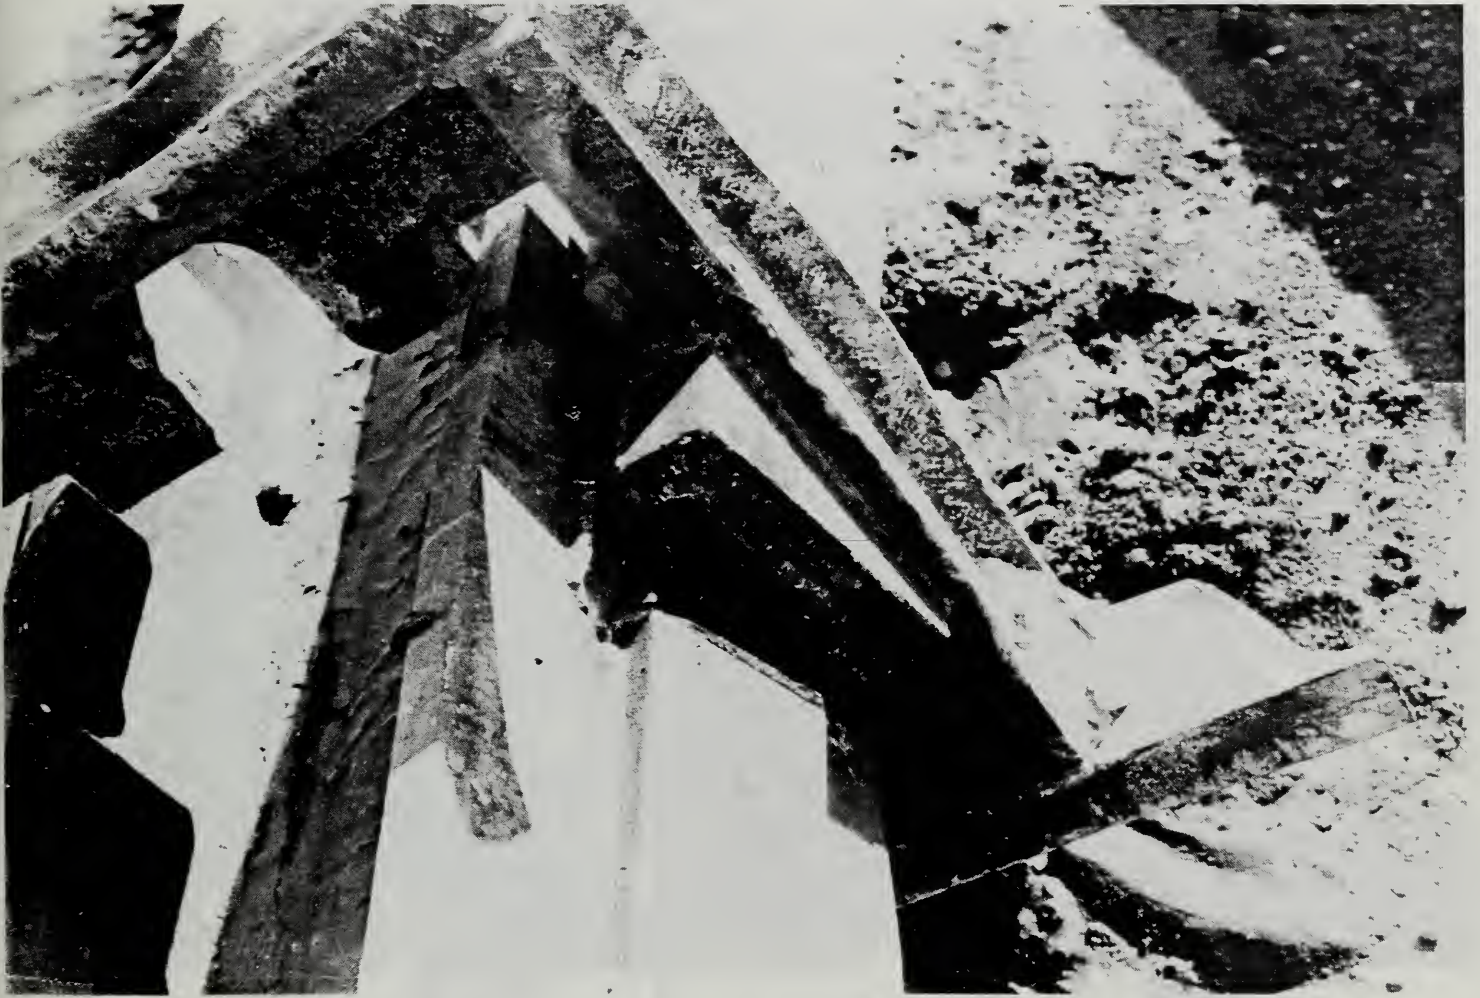
Figure 4.4.24 Weld failure at weld block

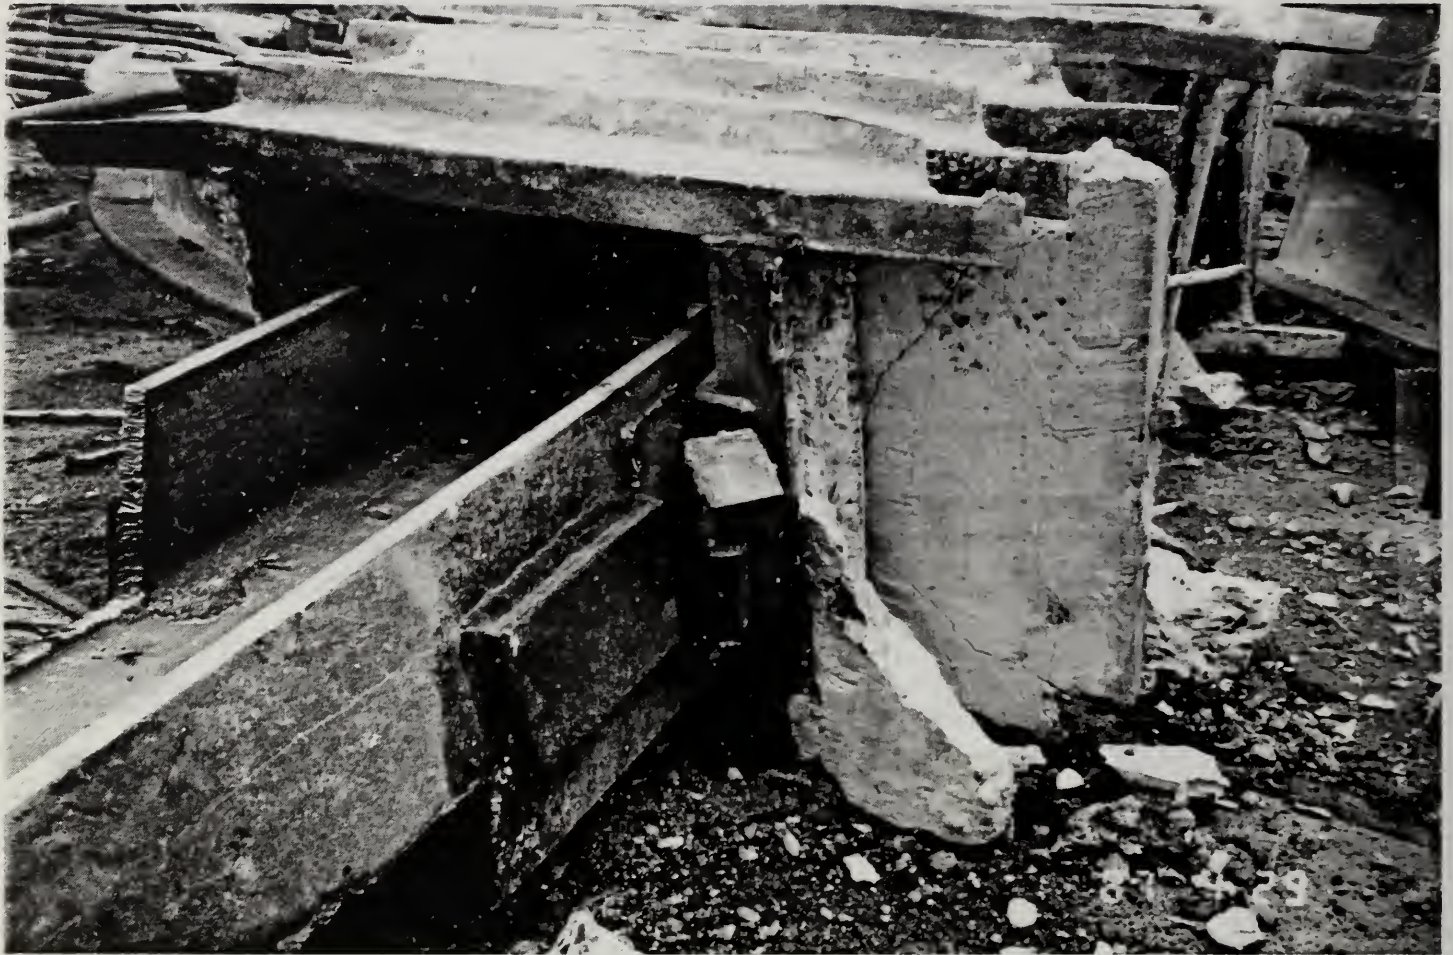
Figure 4.4.25 Weld failure at weld block with shim

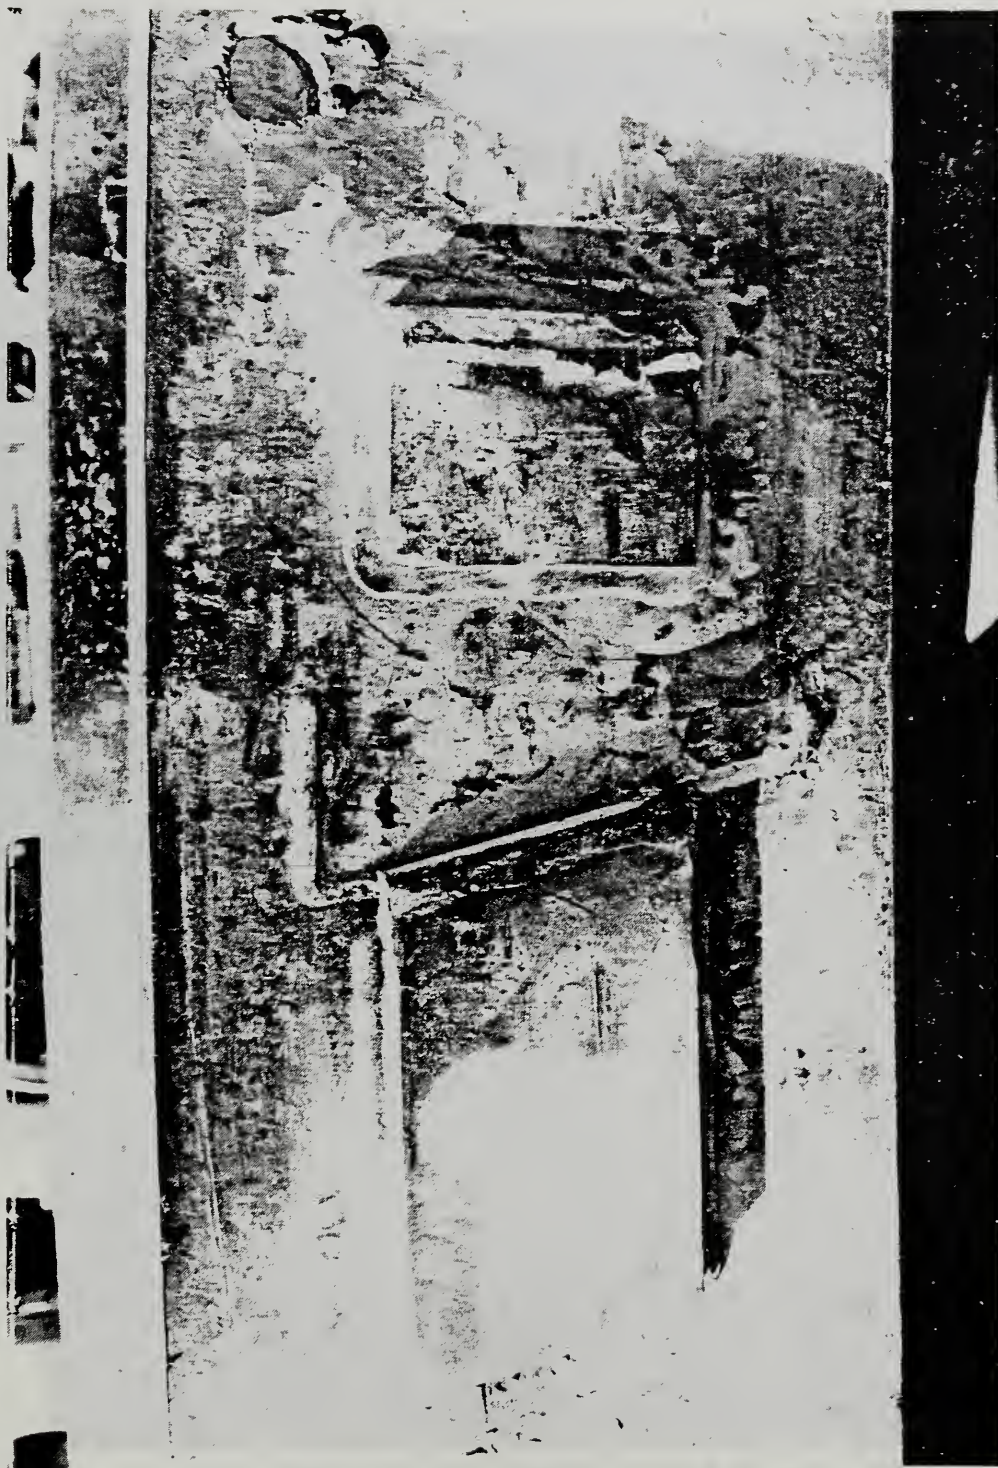
Figure 4.4.26 Weld failure at weld block

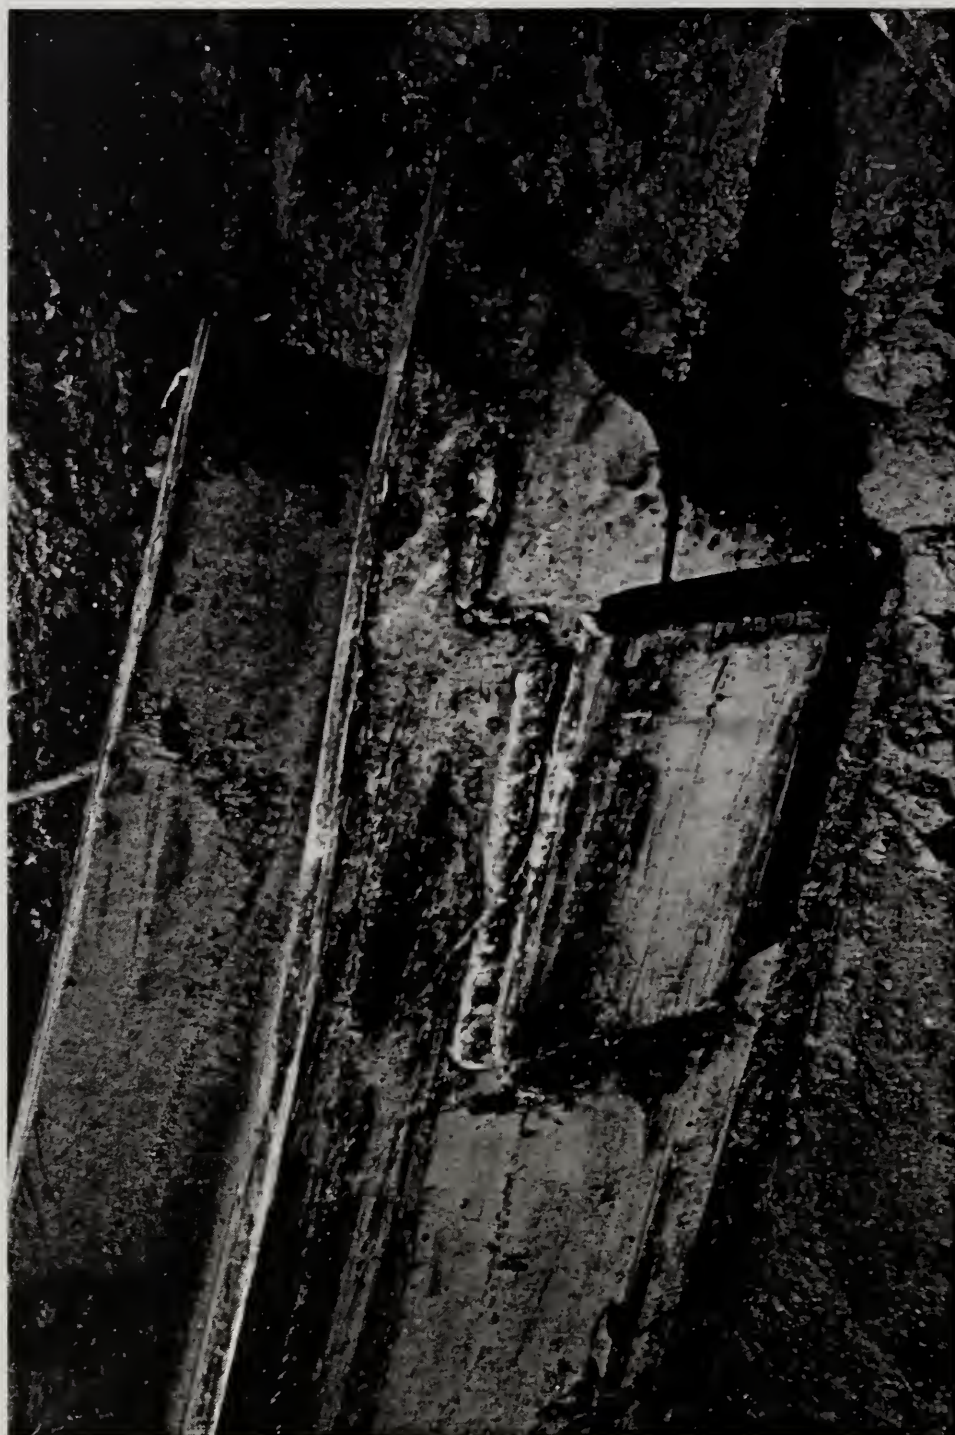
Figure 4.4.27 Weld block weld failure

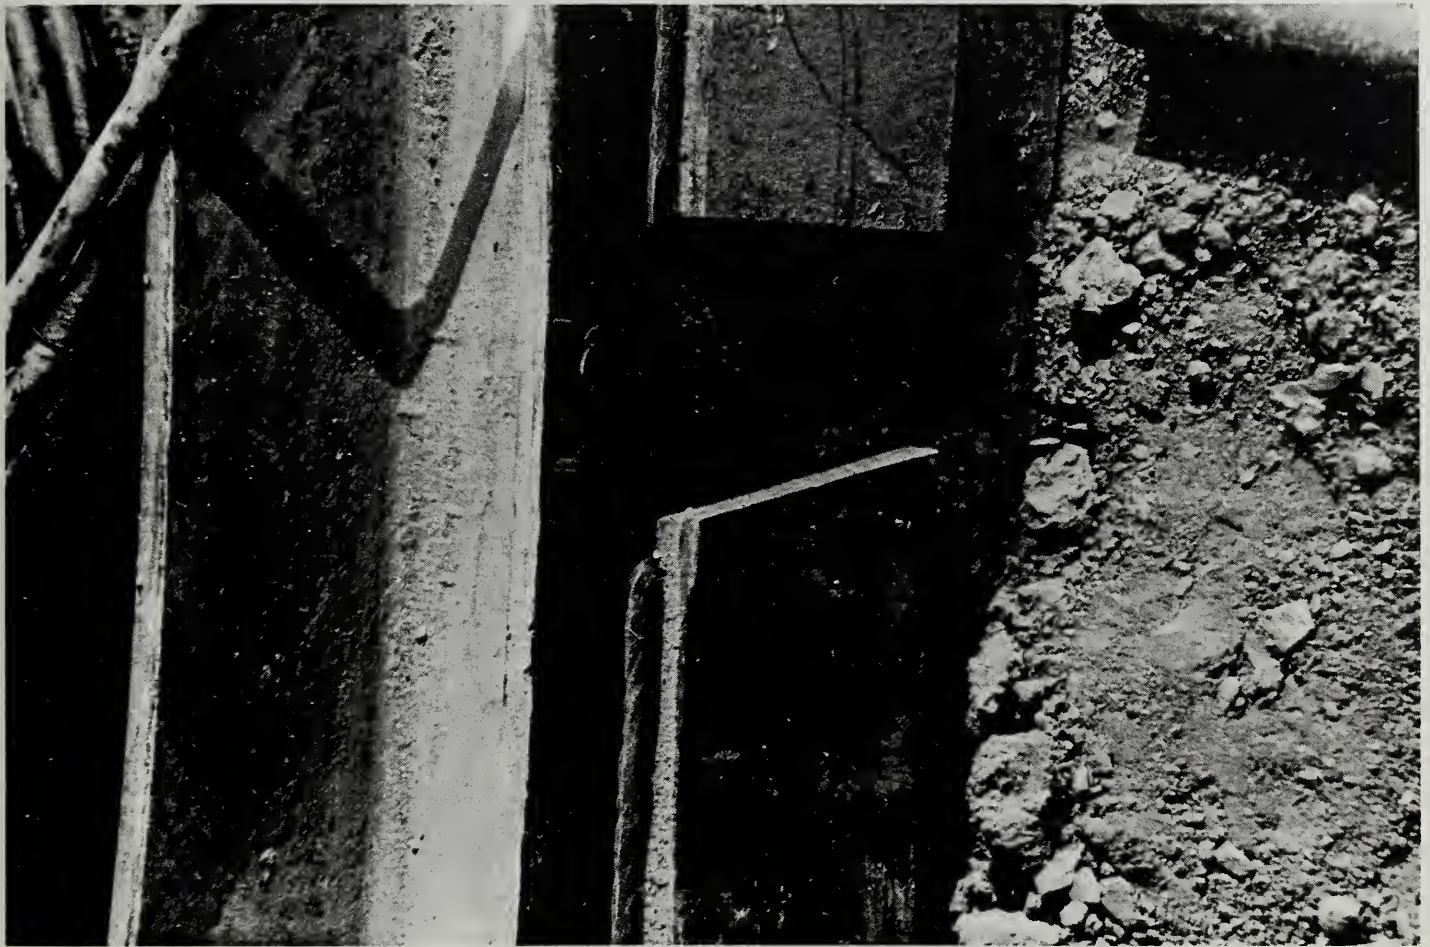
Figure 4.4.28 Failure of temporary weld at shearhead support

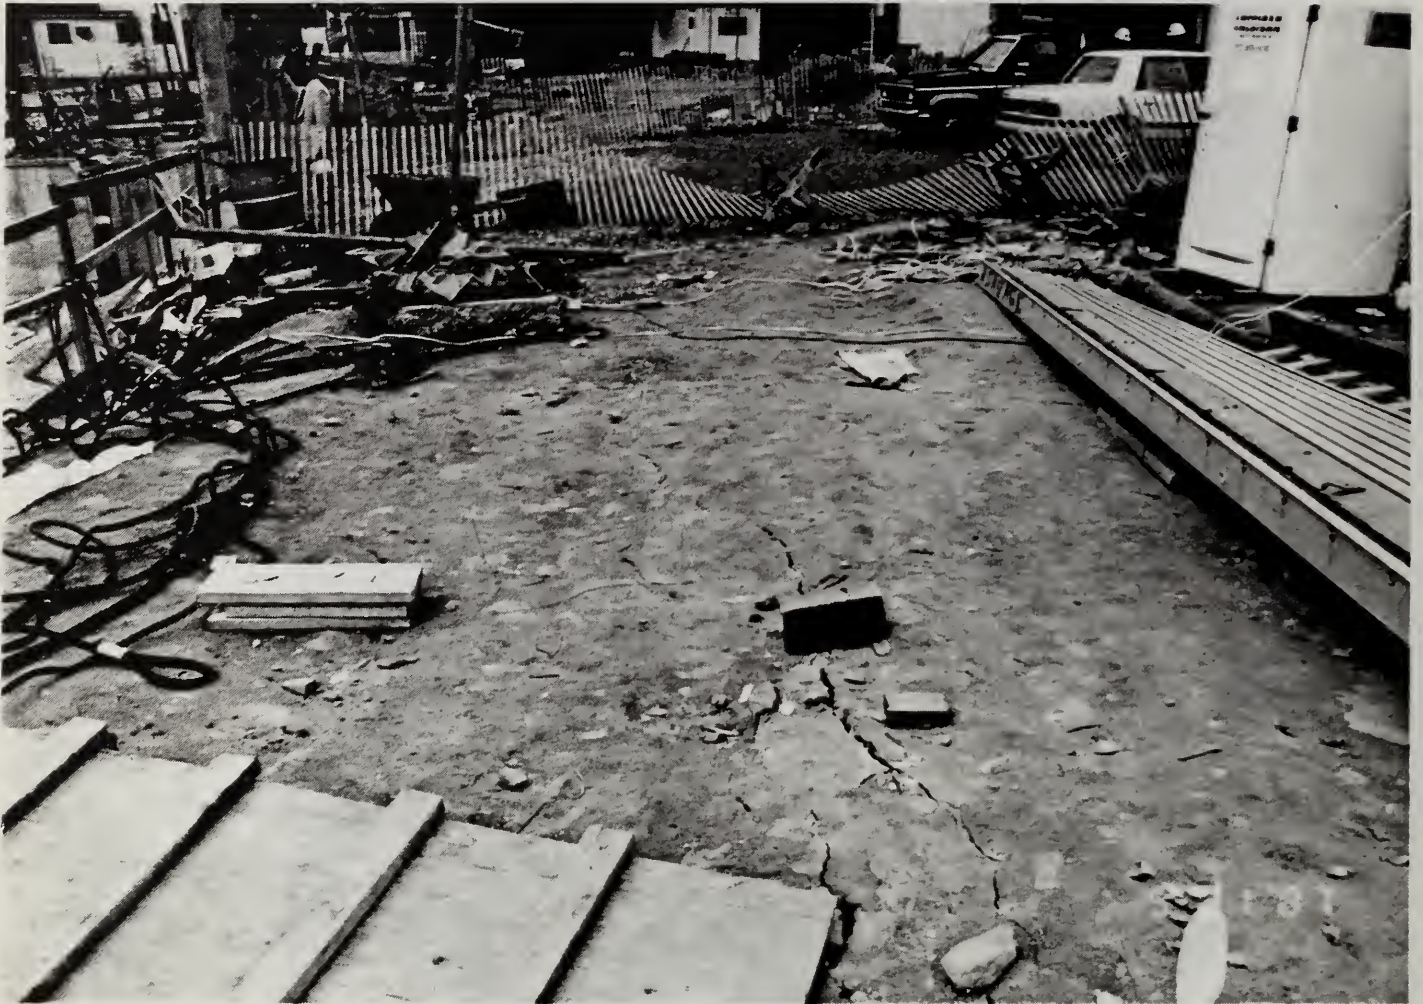
Figure 4.4.31 Tension cracks in backfill behind basement wall – North side of building

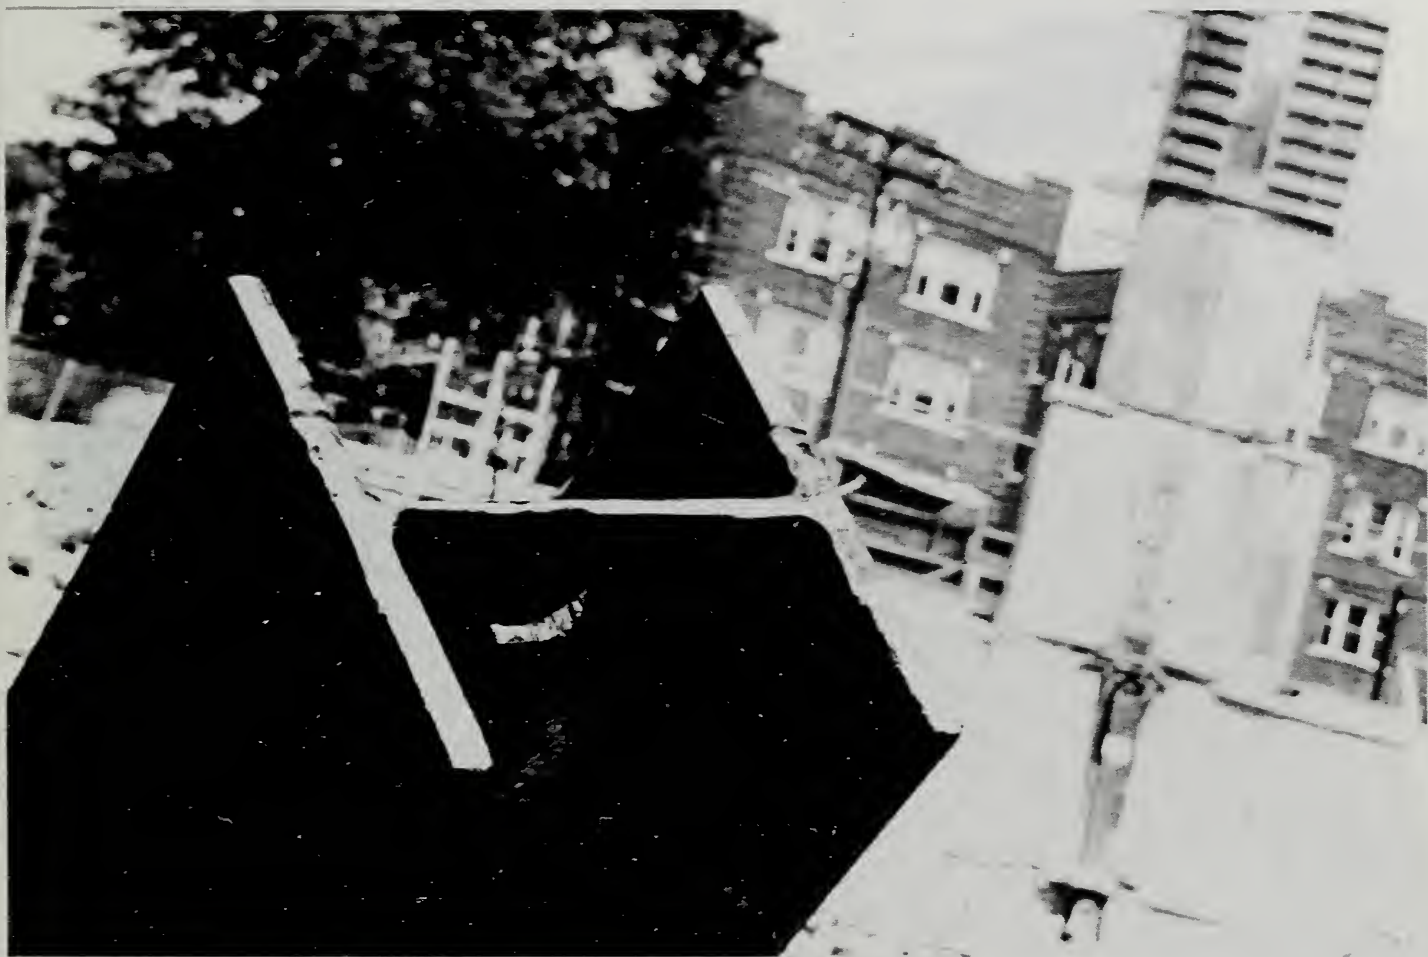
Figure 4.4.32 Typical indentation in top of column due to lifting jack

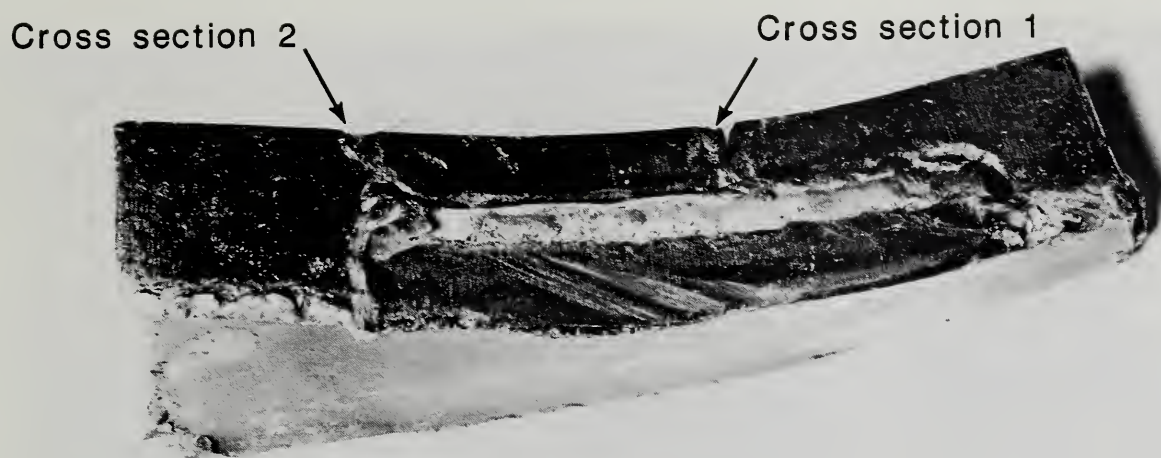
Figure 5.4.12 Fracture of fillet weld on wedge – specimen NBS 33B

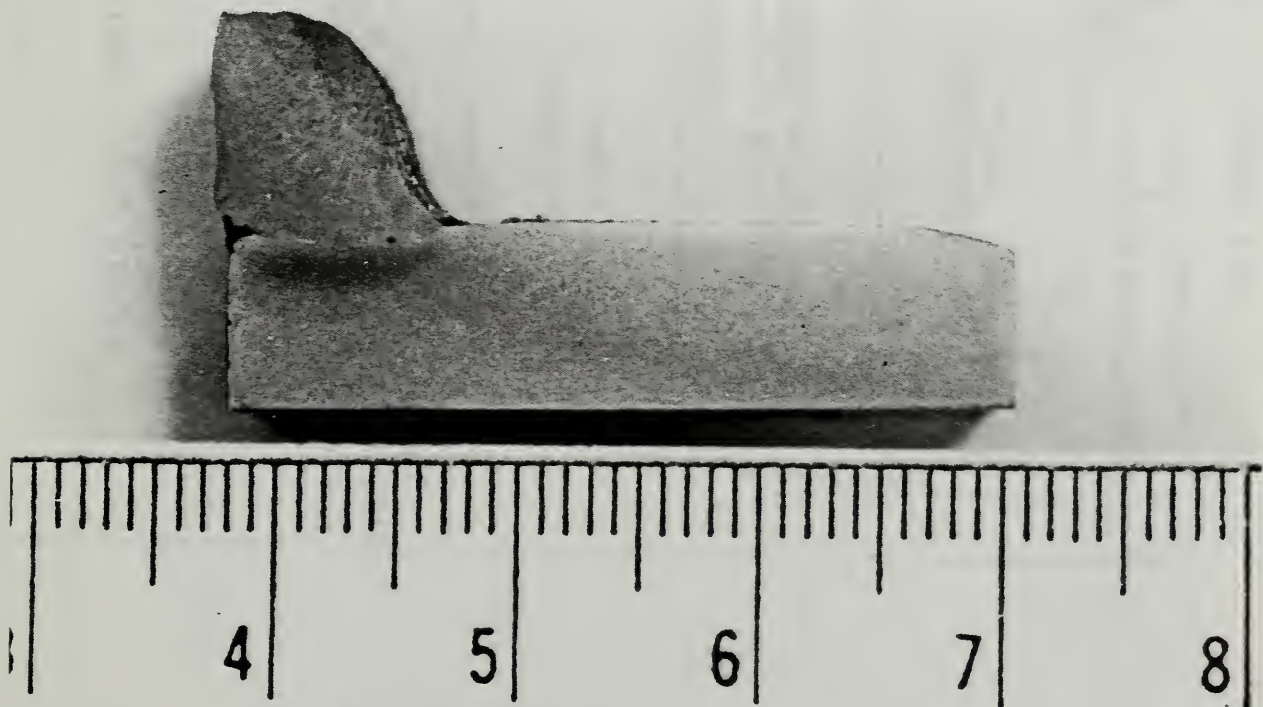
Figure 5.4.16 Metallographic cross section of failed weld
along weld/column interface - specimen
NBS 33A

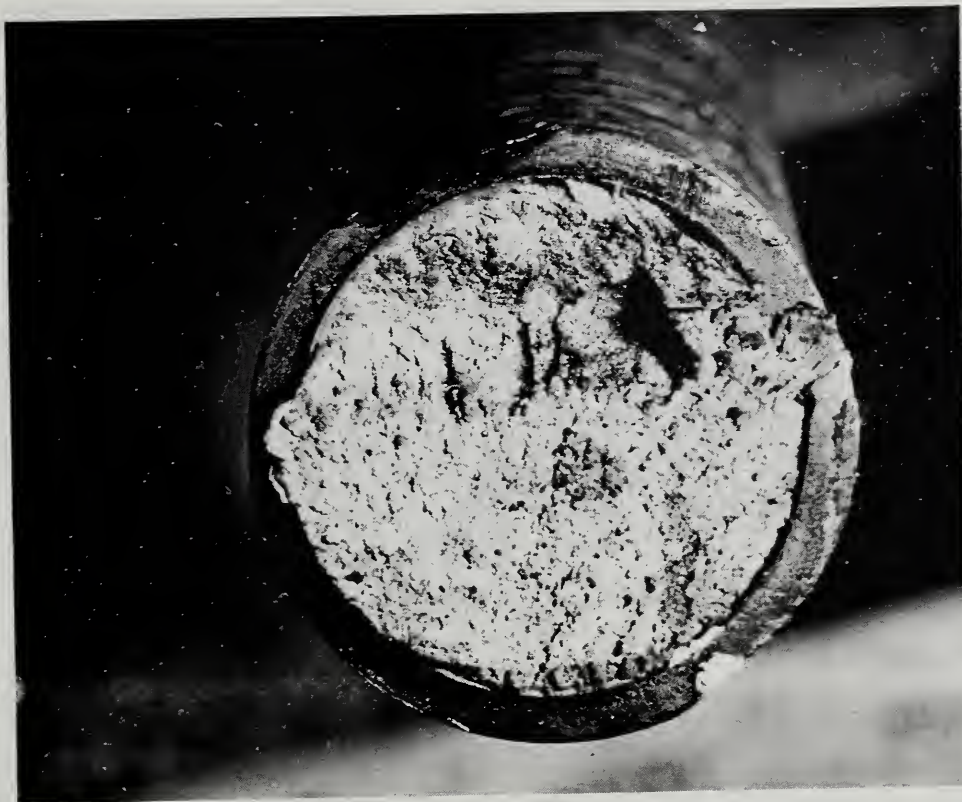
Figure 5.5.5 Fracture surface of jack rod, sample NBS 11-2 (x 1)

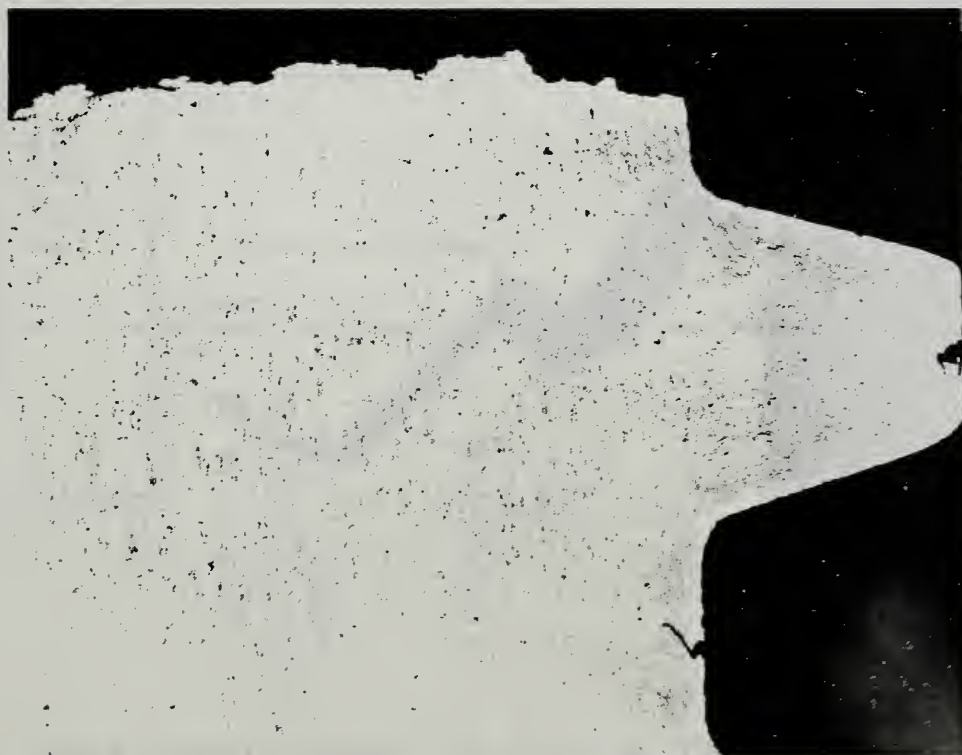
Figure 5.5.6 Fracture profile of jack rod, left, first thread adjacent to fracture (Sample NBS 11-2) (x 9)

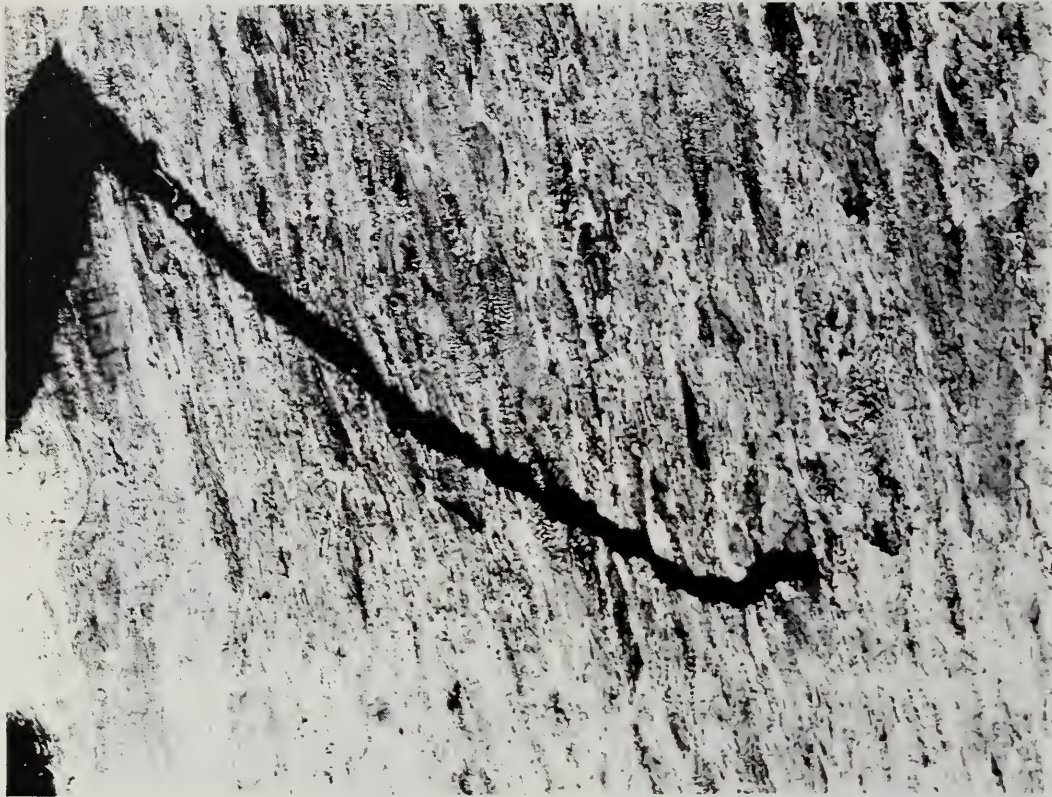
Figure 5.5.7 Lap seam at root of first thread removed from fracture of jack rod (Sample NBS 11-2) (x 500)

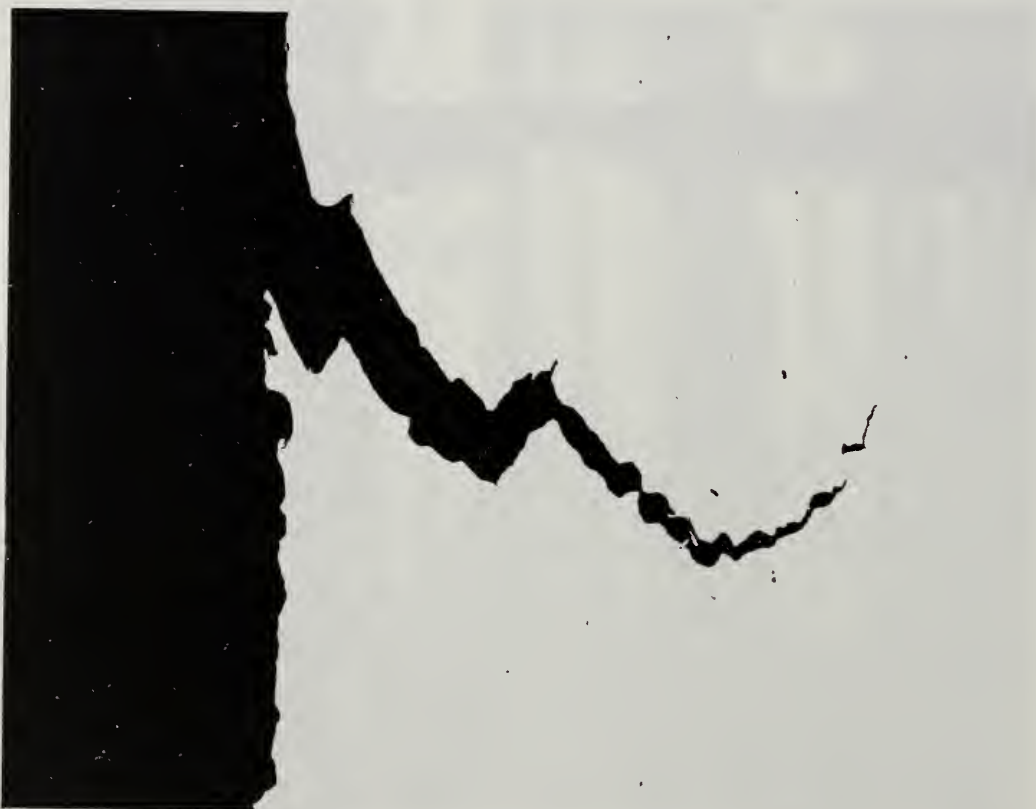
Figure 5.5.8 Lap seam at root of second thread away from fracture of jack rod. As polished (x 40)

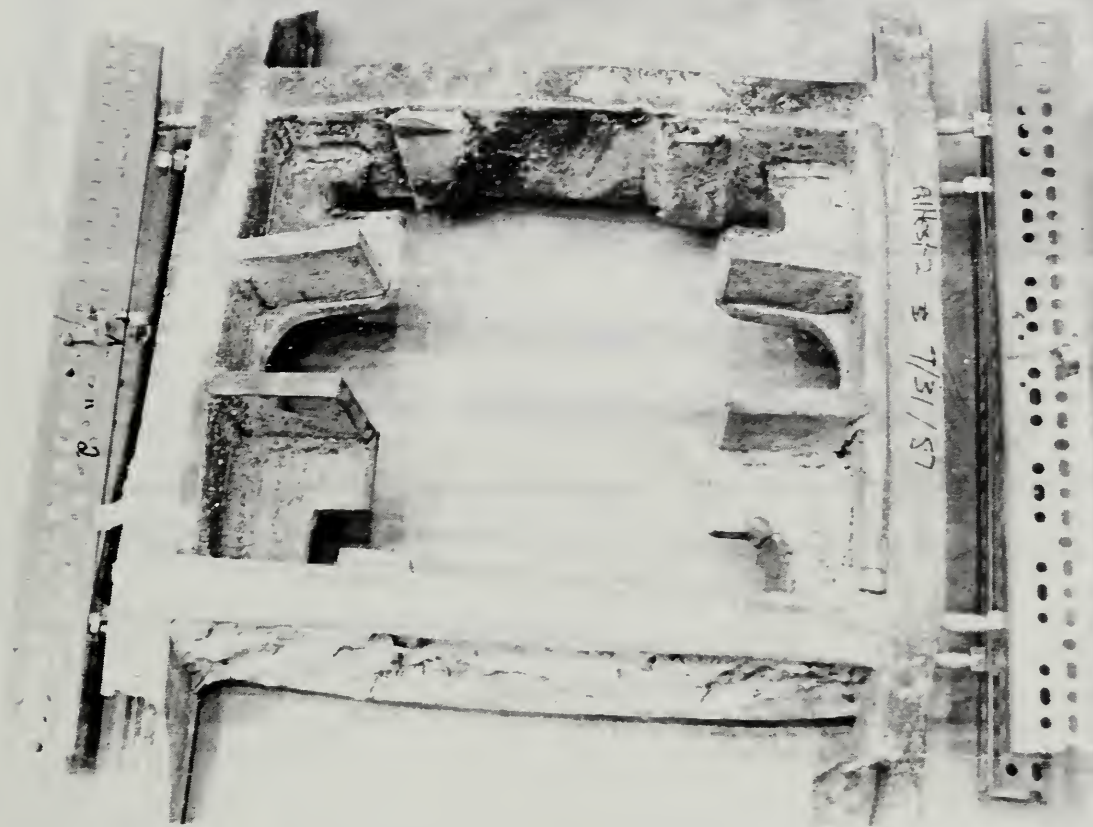
Figure 5.5.17 Shearhead No. 2 after failure showing rotation of lifting angles

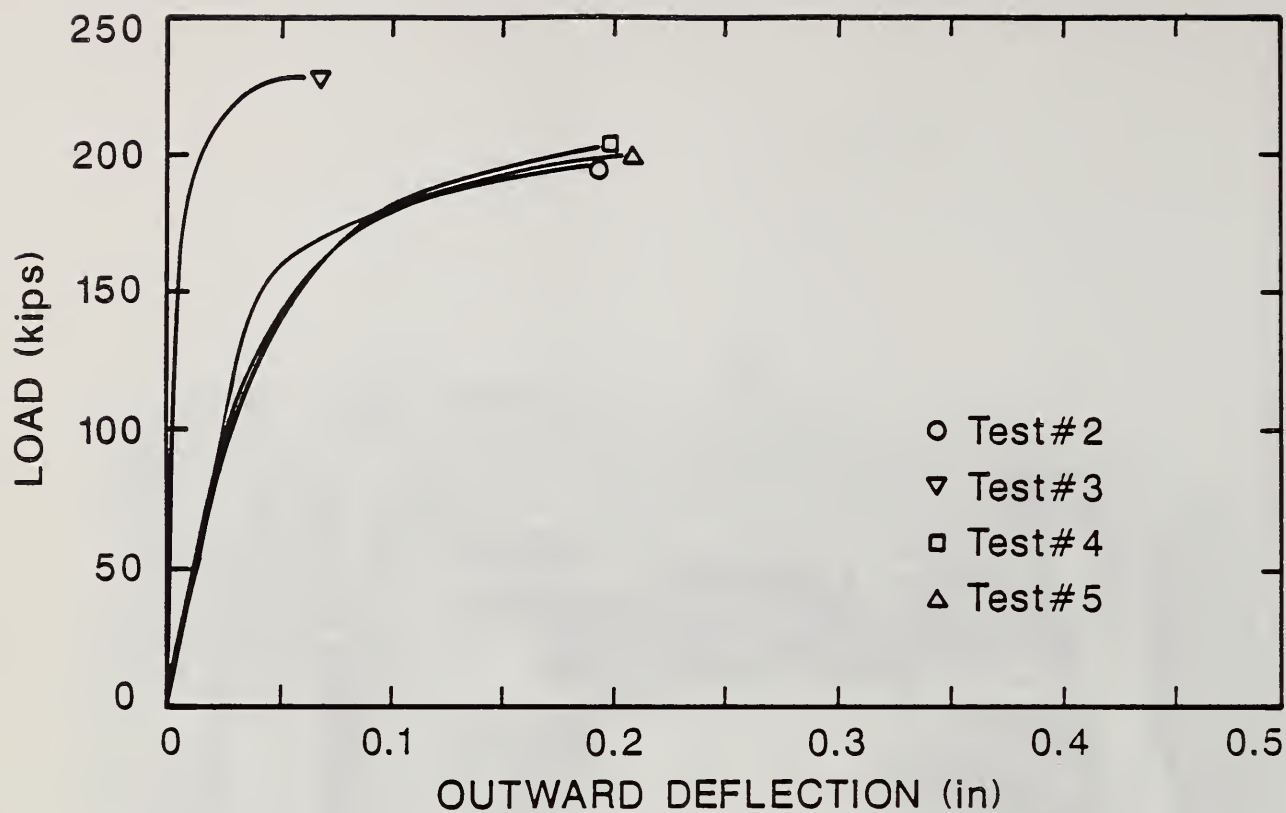
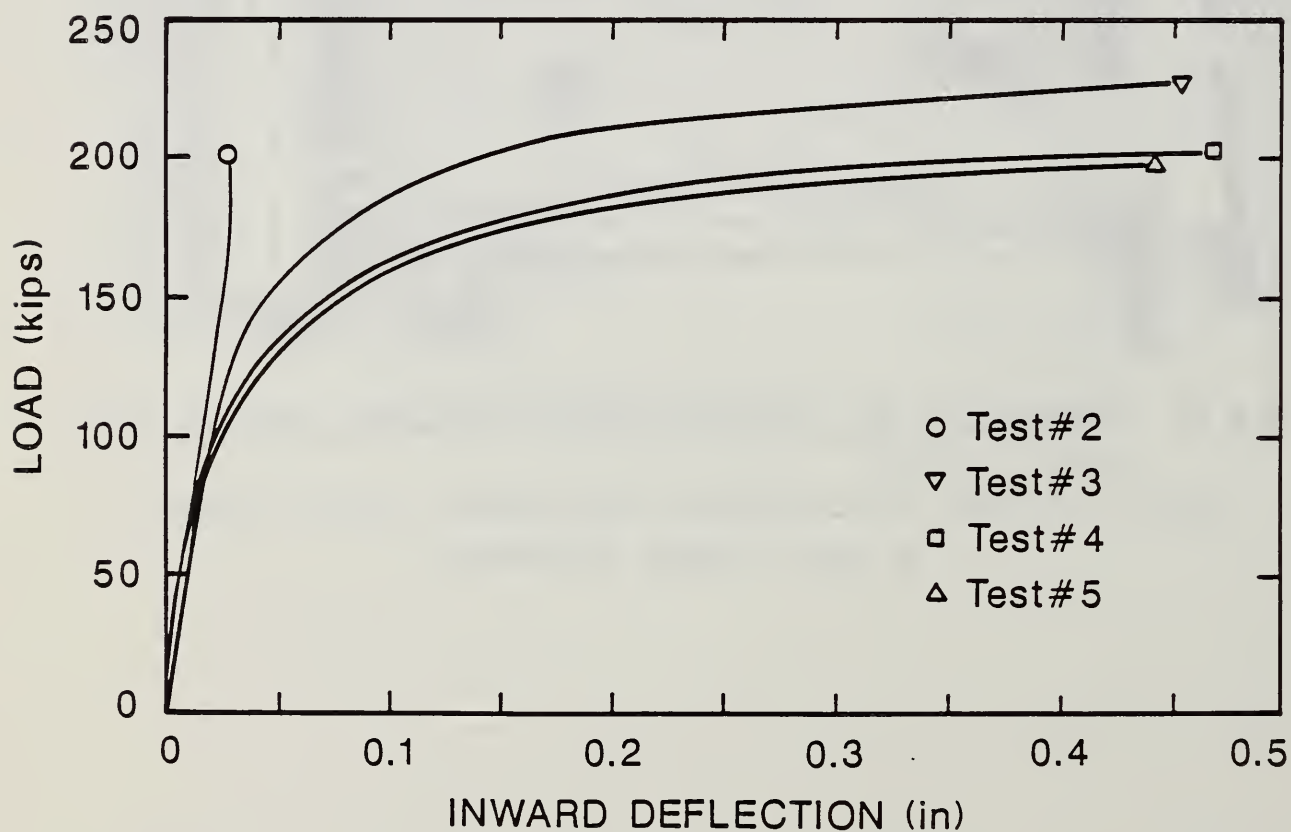
Figure 5.5.18 Lateral deformation of shearhead - failure side

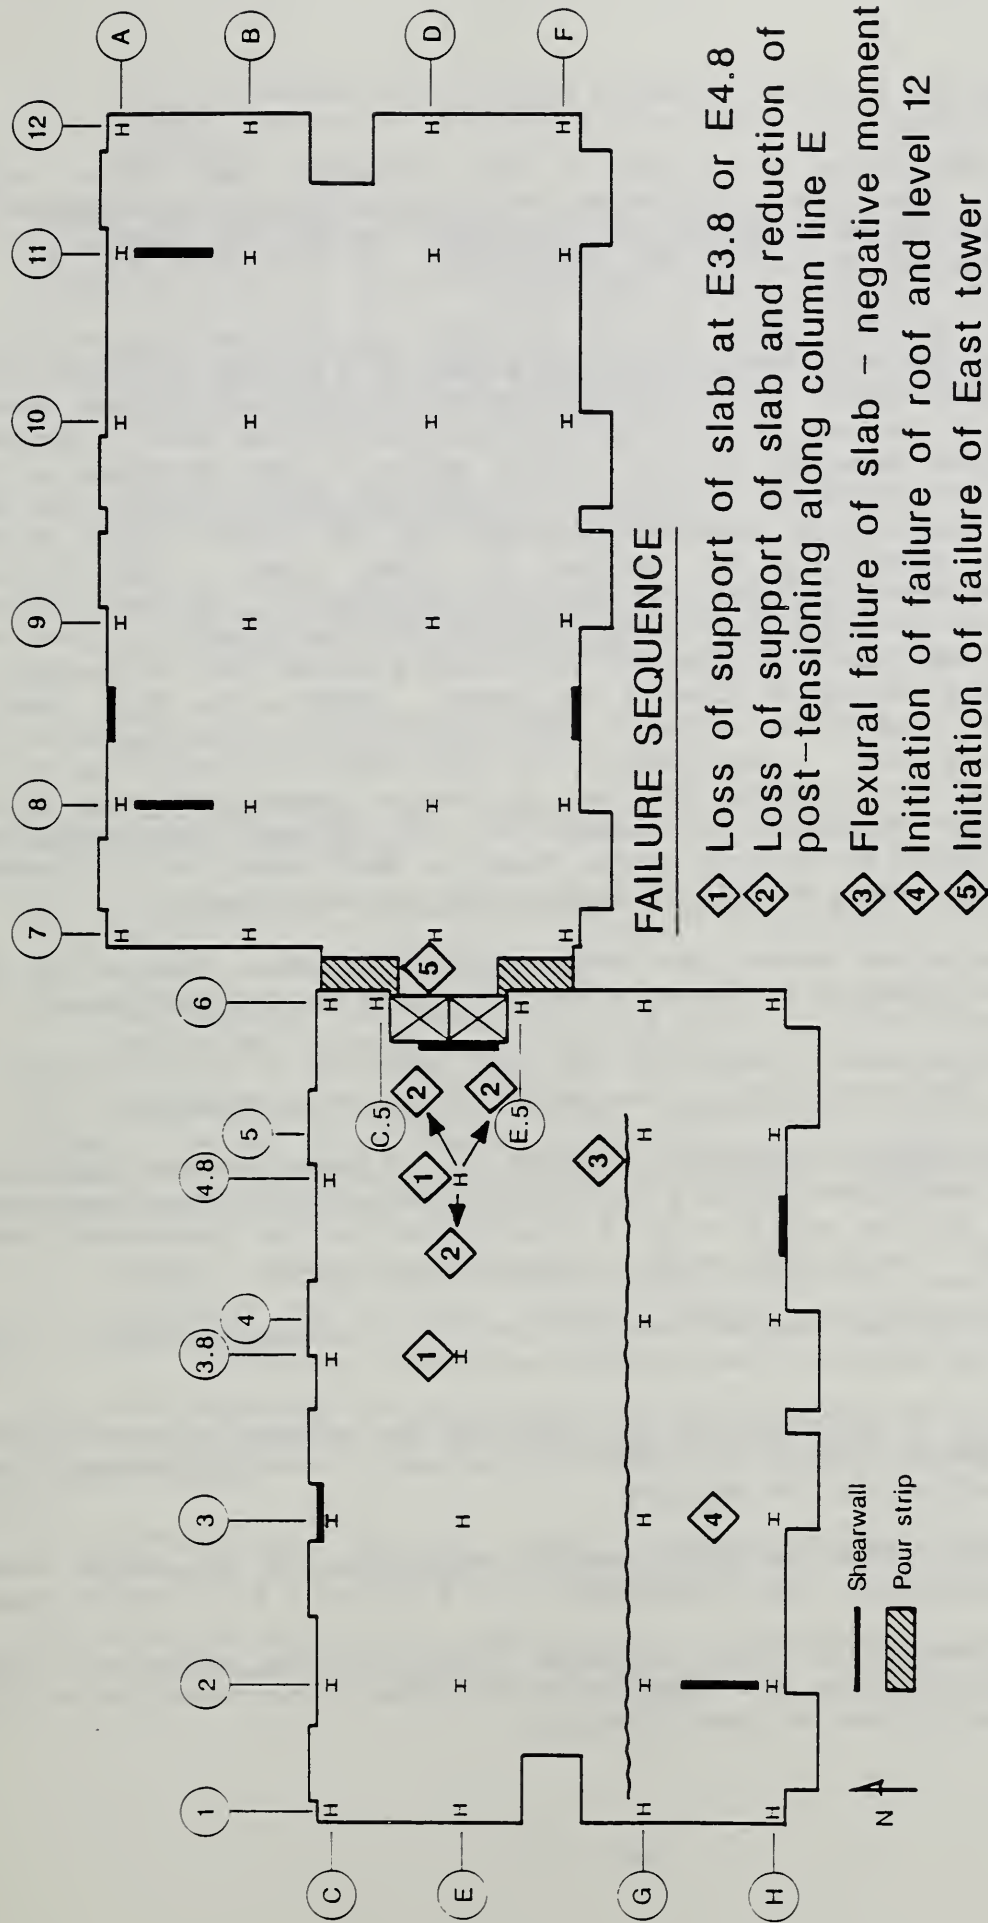
1. The most probable cause of the collapse was failure of the lifting system in the west tower during placement of a package of three upper level floor slabs. The failure most probably began below the most heavily loaded jack (column E4.8) or an adjacent jack (column E3.8). Excessive deformations occurred in the lifting angle of the shearhead at the location of the initial failure. This was followed by one of the jack rods in the lifting assembly slipping off the lifting angle in the shearhead supporting the package of three slabs. This failure mechanism was duplicated in laboratory experiments. The local failure propagated as loads were redistributed and the remaining jack rods along column line E slipped off the lifting angles and the package of three slabs failed in flexure and shear. These slabs fell, causing the lower level slabs to fail. This resulted in the collapse of the entire west tower. Consequently, the east tower collapsed due to one or more of the following factors: (a) forces transmitted to it by the west tower collapse, (b) damage to the post-tensioning tendons caused by falling debris from the west tower, or (c) lateral instability caused by falling debris from the west tower.

Figure 9.4.1 Probable failure sequence
